November 1, 2021

Schooner Yacht Association
73 Harbor Drive
Stamford, CT 06902

Reference: Underwater Investigations of Timber Pilings at Schooner Cove Yacht Association

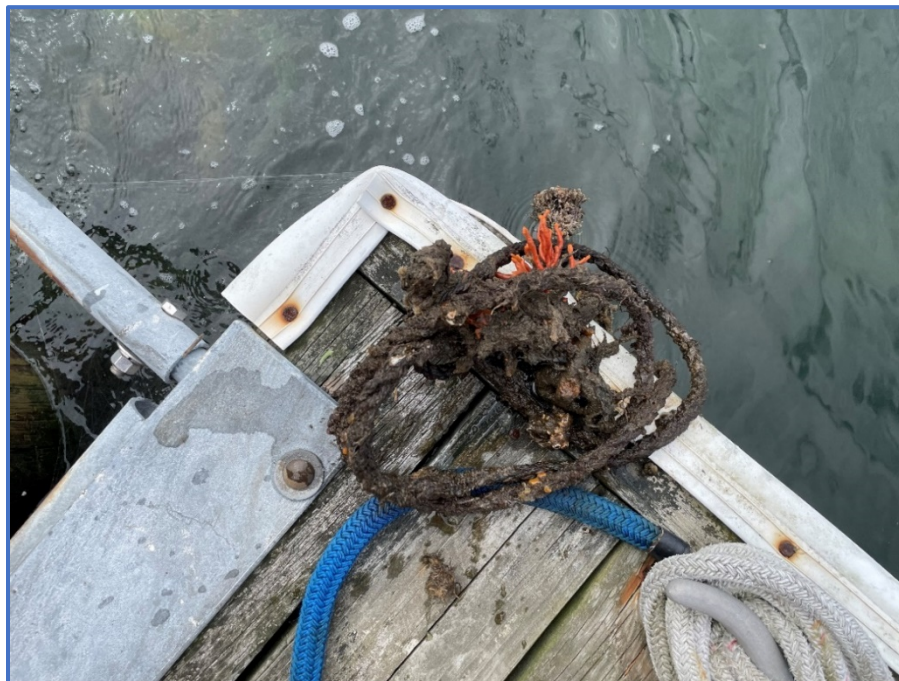
Storm Anchors that were intact and able to be observed include: # 1, #2, #4, and #5 per the plan provided to RACE by SCYA. RACE identified at multiple locations either broken chain or snapped lines as shown in the photo below.

Photograph 1: Typical condition of broken line where anchor connection is located

4. Several storm anchors are missing or in deteriorated condition. If these are determined to be necessary for marina performance than they should be appropriately addressed.

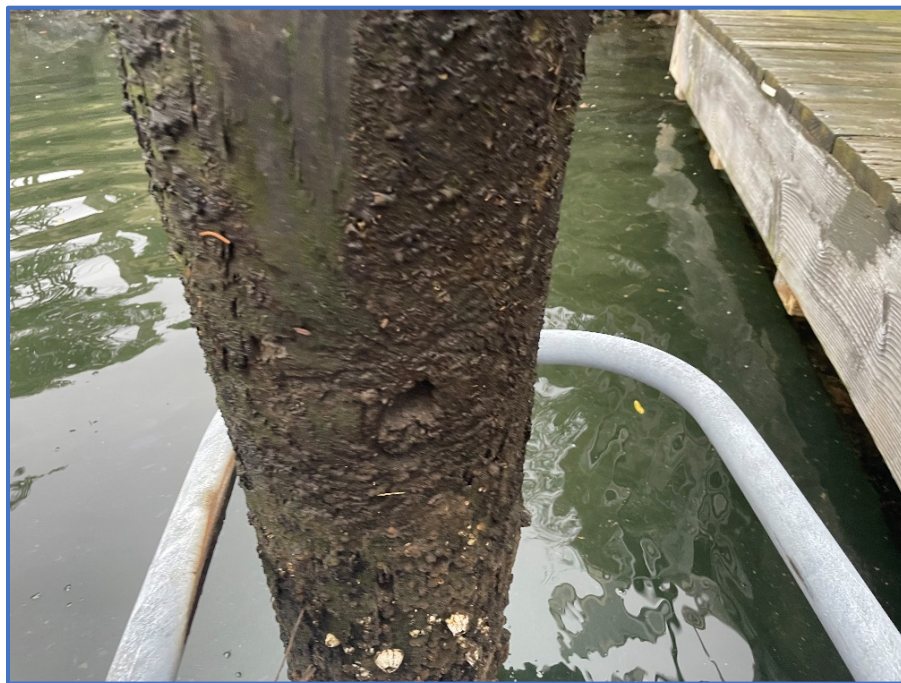
Numerous timber piles had marine borer damage as shown, please see Photograph 2. Marine borer damage can be classified as two types: crustacean borers and molluscan borers. The *Limnoria* is waterborne, surface crustacean. It is also known as the wood loose or gribble. Gribbles tunnel their way through the wood with a 1/4" size hole and continue to burrow through a pile over time causing the pile to become deteriorated and have a sponge like feel.

Photograph 2: Typical marine borer damage at knot of piling

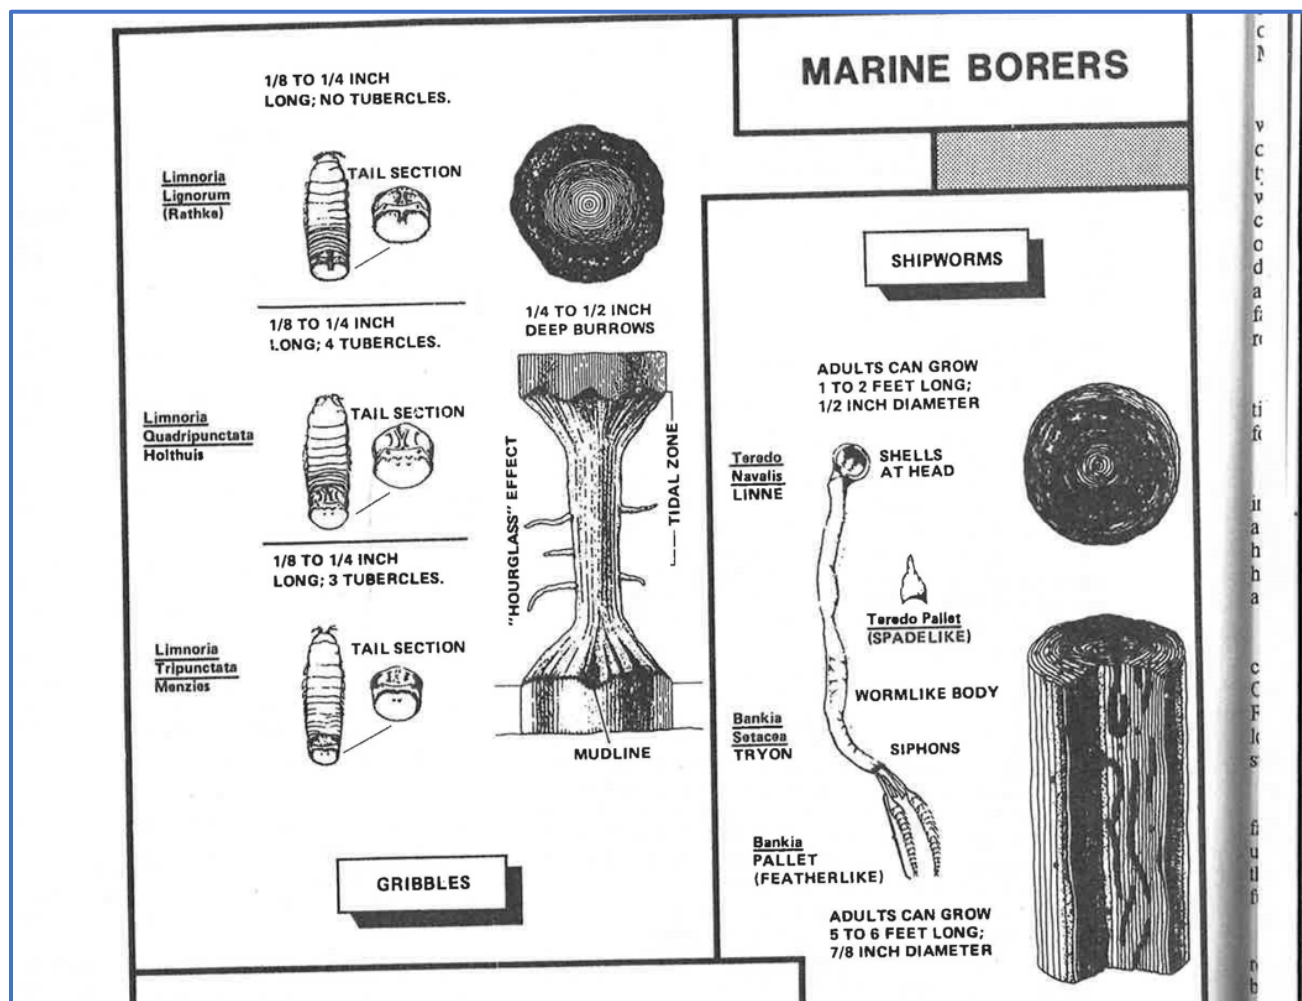
Extent of damage caused by marine borers is difficult to determine from a Level 1 inspection. This is because this type of inspection is limited to the surface of the inspected pile while borer infestation occurs within the pile. Destructive testing by removing and cutting open a pile is the most definitive way to ascertain internal damage level. Figure 1, below, depicts damage on timber piles from marine borers.

Figure 1: Marine Borer Damage

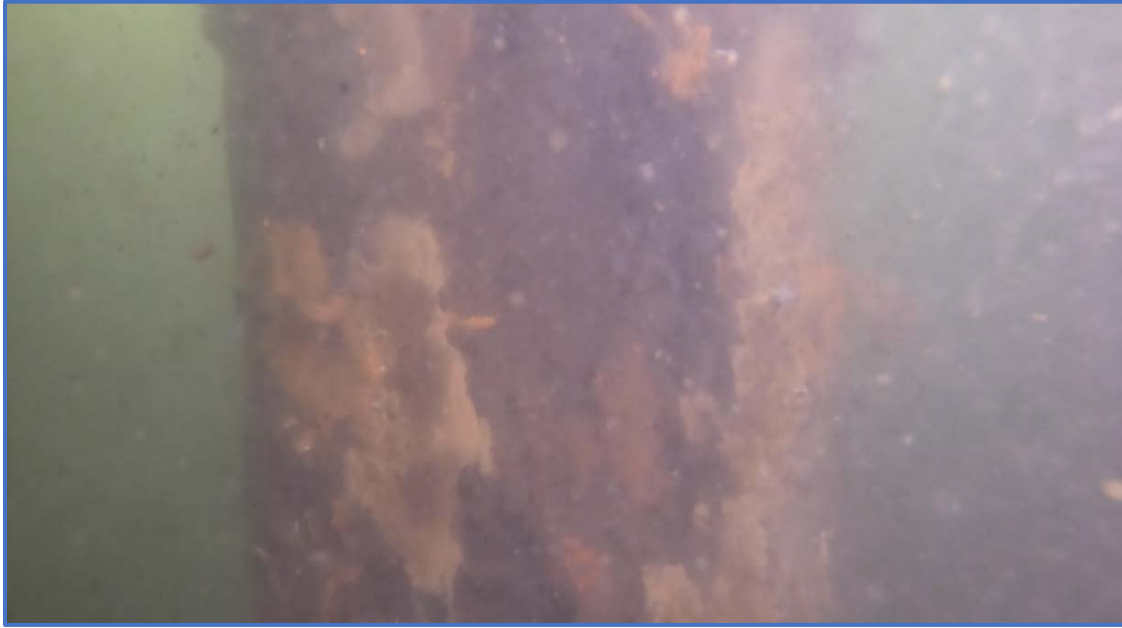
Significant marine borer damage was observed on pile numbers 6, 16, 22, 26, 79, 83, 85, F-1, F-3, and F-4. The pilings on the fixed platform, which is located north of the property, are in **Poor/Serious** condition. In this area half of the piles were deteriorated by ice and marine borer damage.

Please refer photograph #3 and photograph #4 following. Photograph 3 depicts conditions of a current, in-service pile, with marina borer damage. Photograph #4, which was provided by SCYA, shows a broken pile with apparent, extensive borer damage. The purpose of showing these two photographs is to demonstrate that there may be much more damage within the pile than is visible at the surface.

Photograph 3: Typical marine borer damage to pilings listed as Poor/Serious

1. Replace pilings 6, 16, 22, 26, 79, 83, 85, F-1, F-3, and F-4 with a timber pile or composite pile.
2. Address pile guides damaging piles: 1, 9, 23, 24, 25, 27, 29, 32, 35, 38B, 45, 46, 50, 51, 54, 63, 64, 65, 66, 75, 80, 89, 96.

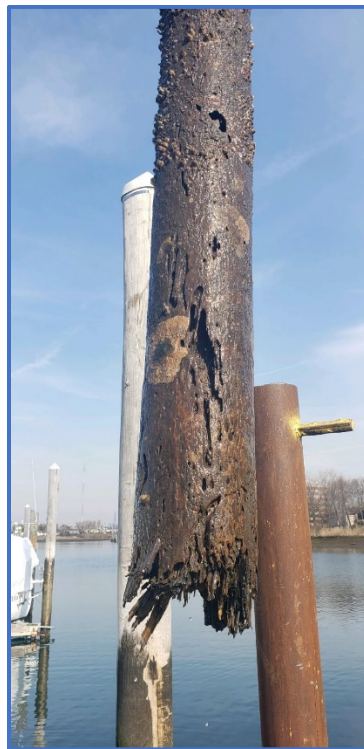
Photograph 4: Broken Pile provided by SCYA

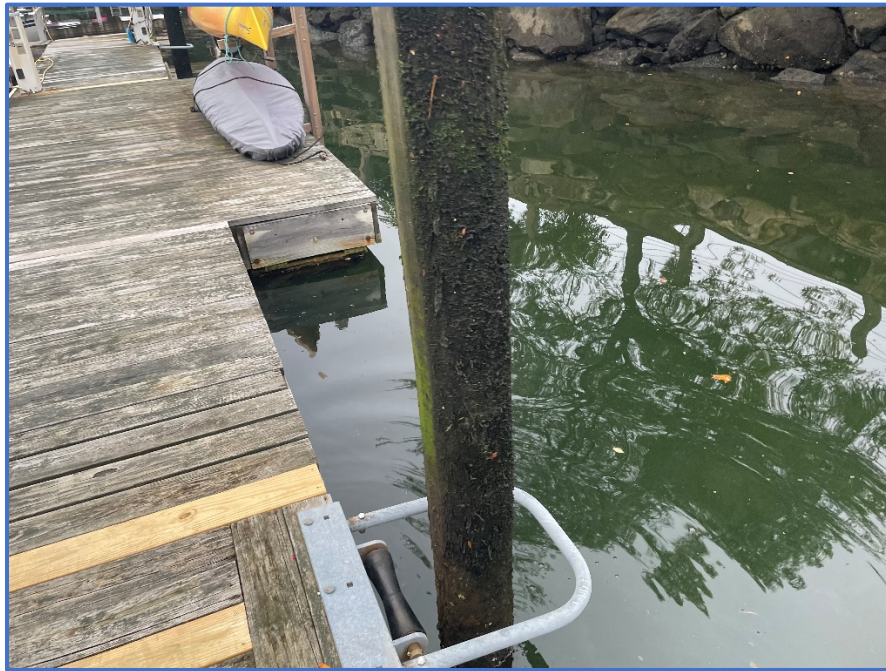
Also, on numerous piles there was abrasion damage caused by either the piles being out of plumb or guide assemblies missing rollers. Please see photograph #3. Piles exhibiting abrasion damage were typically rated **Satisfactory / Fair**.

Photograph 5: Typical wear and tear from pile guide

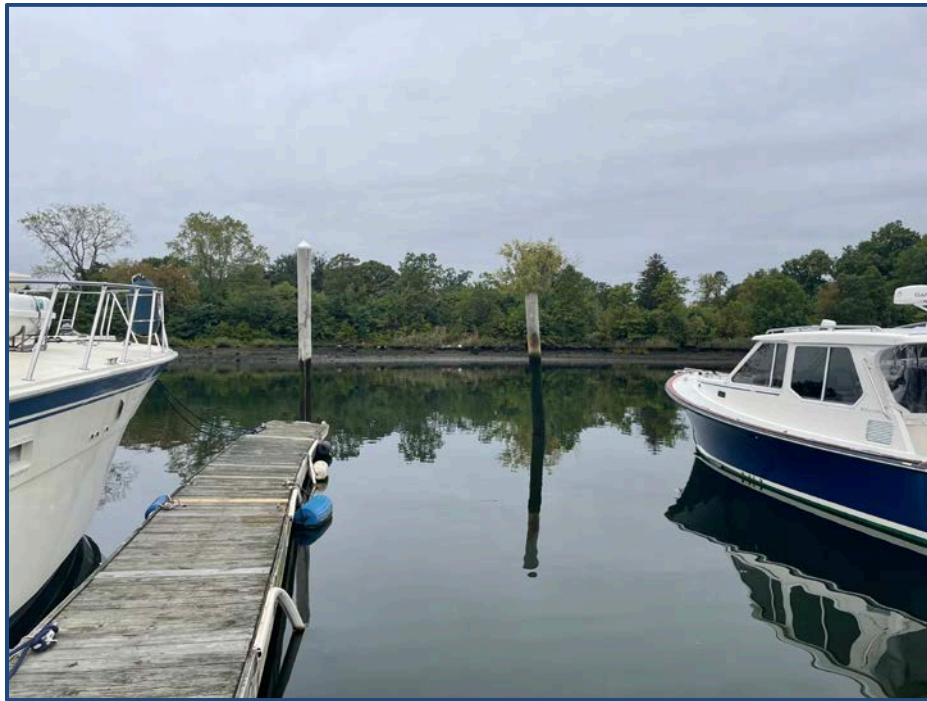
Photograph 1 – Pile number 44 is outlier in pile layout; only area with a tie off pile

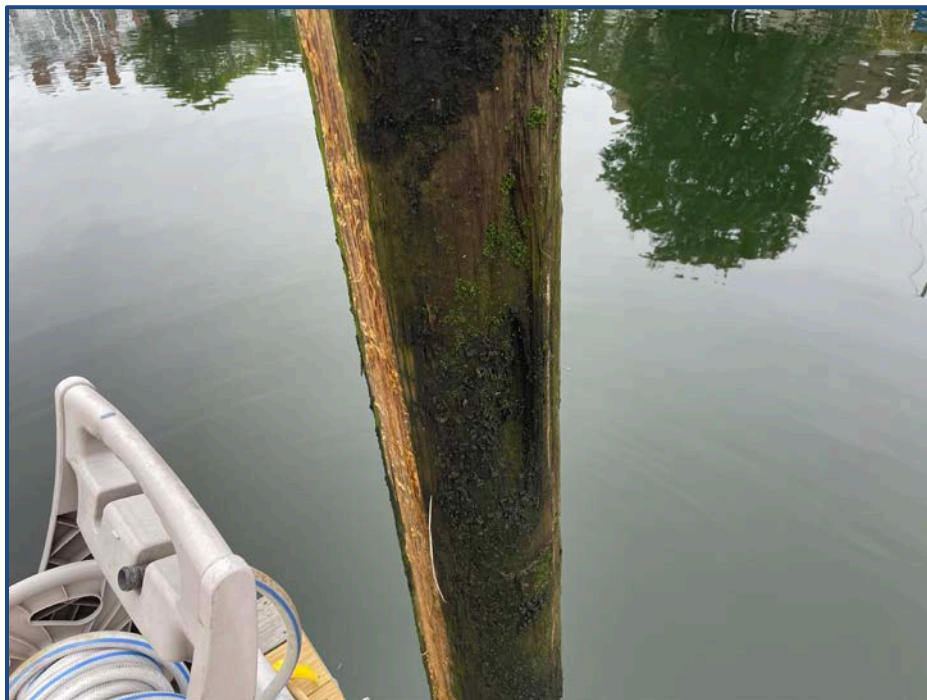
Photograph 2 – Typical abrasion damage from pile guide

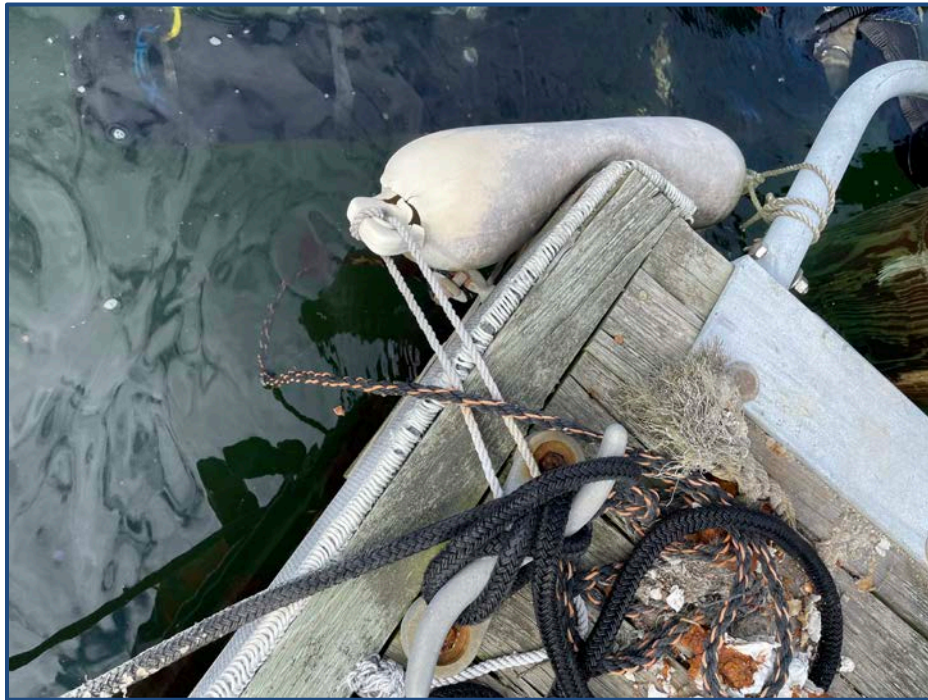
Photograph 3 – 3/8" line broken where anchor attachment location is marked

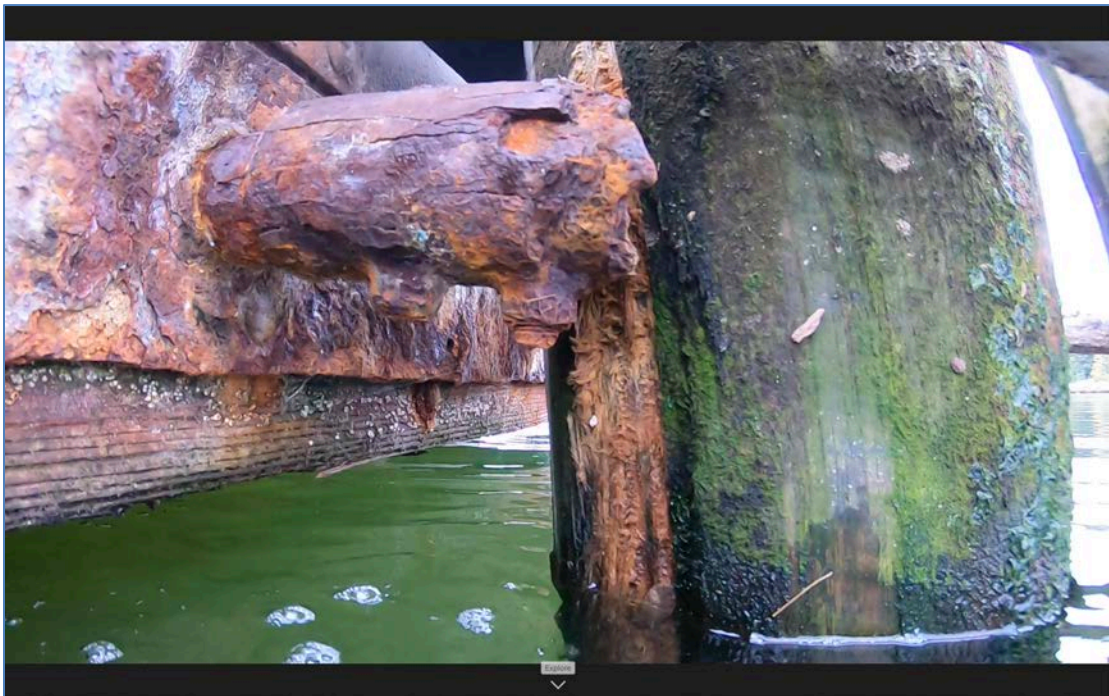
Photograph 4 – Abrasion damage from broken pile guide

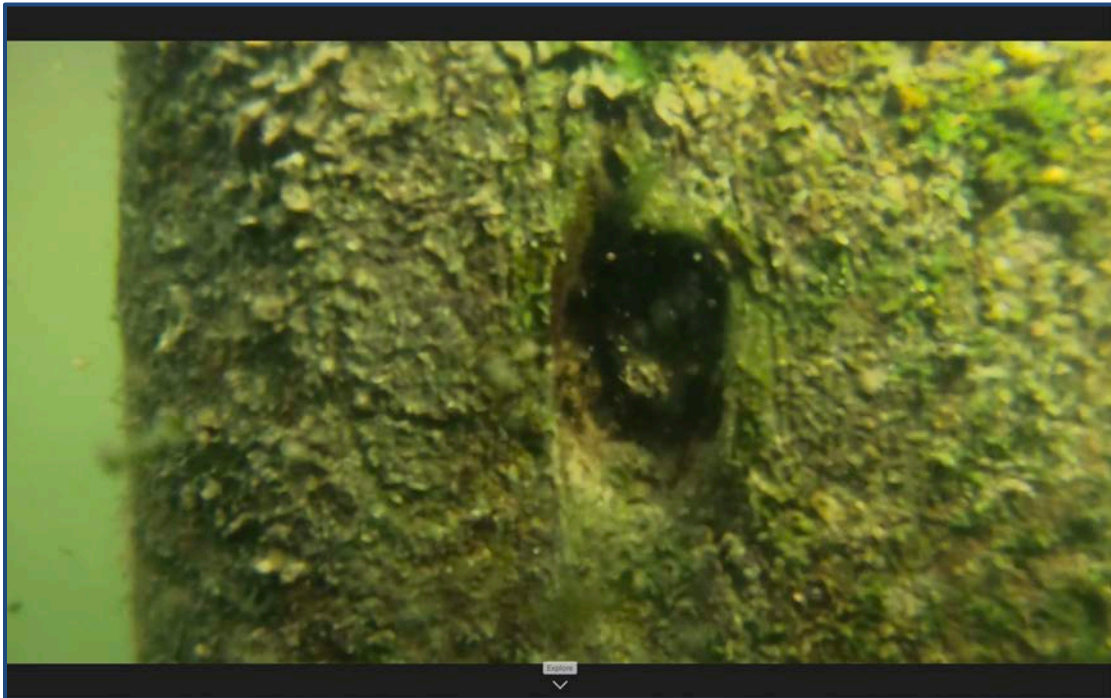
Photograph 5 – Marine borer damage at a knot in the pile

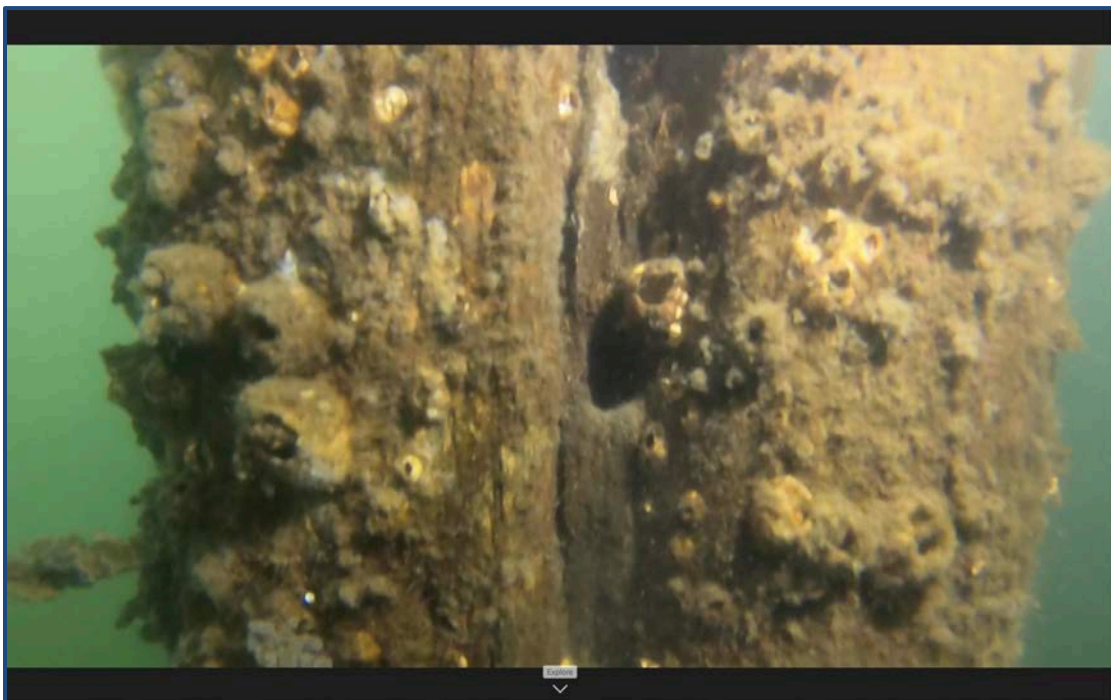
Photograph 6 – Marine borer damage in pile

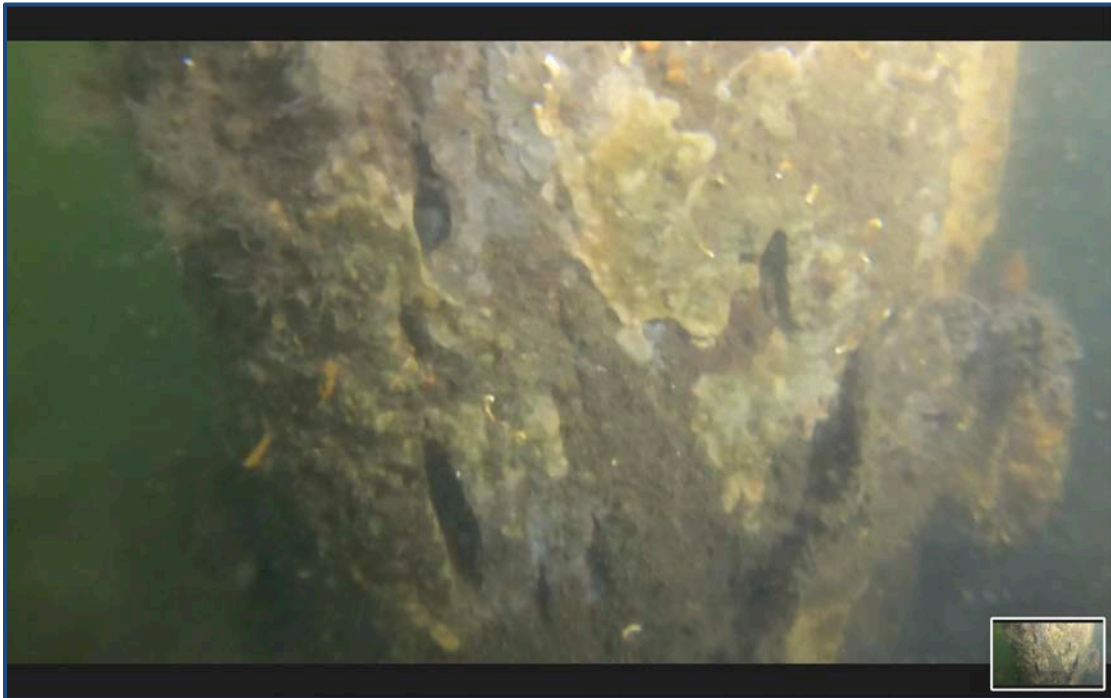
Photograph 7 – Significant marine borer damage in pile

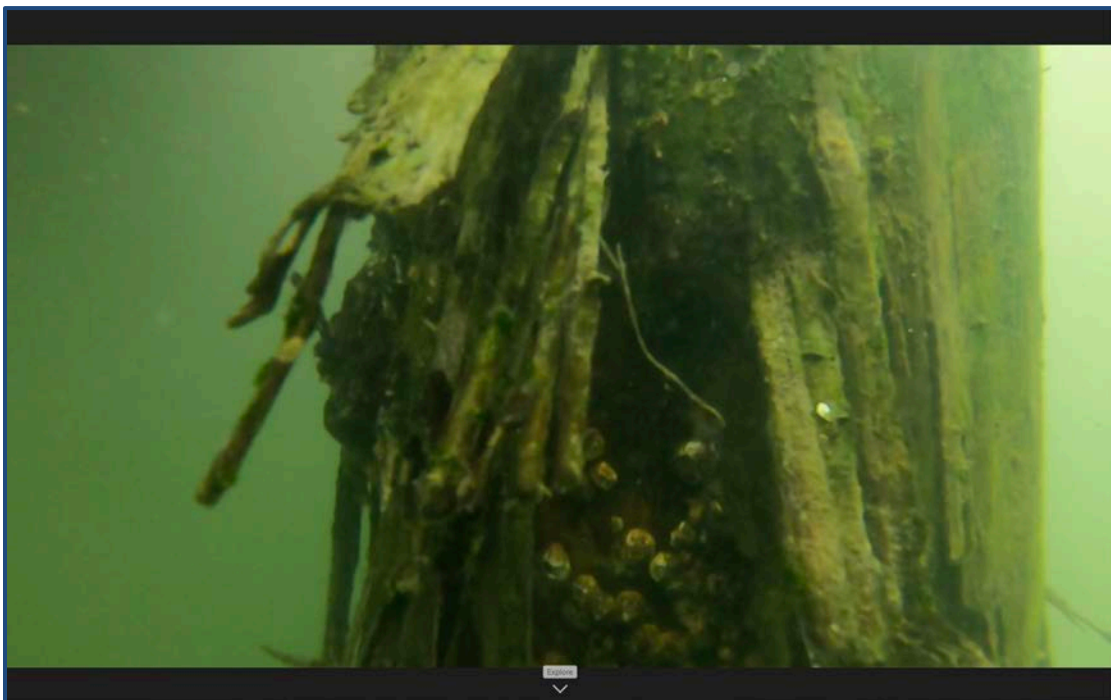
Photograph 8 – Severe ice damage in pile 5' below Mean High Water
