November 1, 2021

Schooner Yacht Association
73 Harbor Drive
Stamford, CT 06902

Reference: Underwater Investigations of Timber Pilings at Schooner Cove Yacht Association

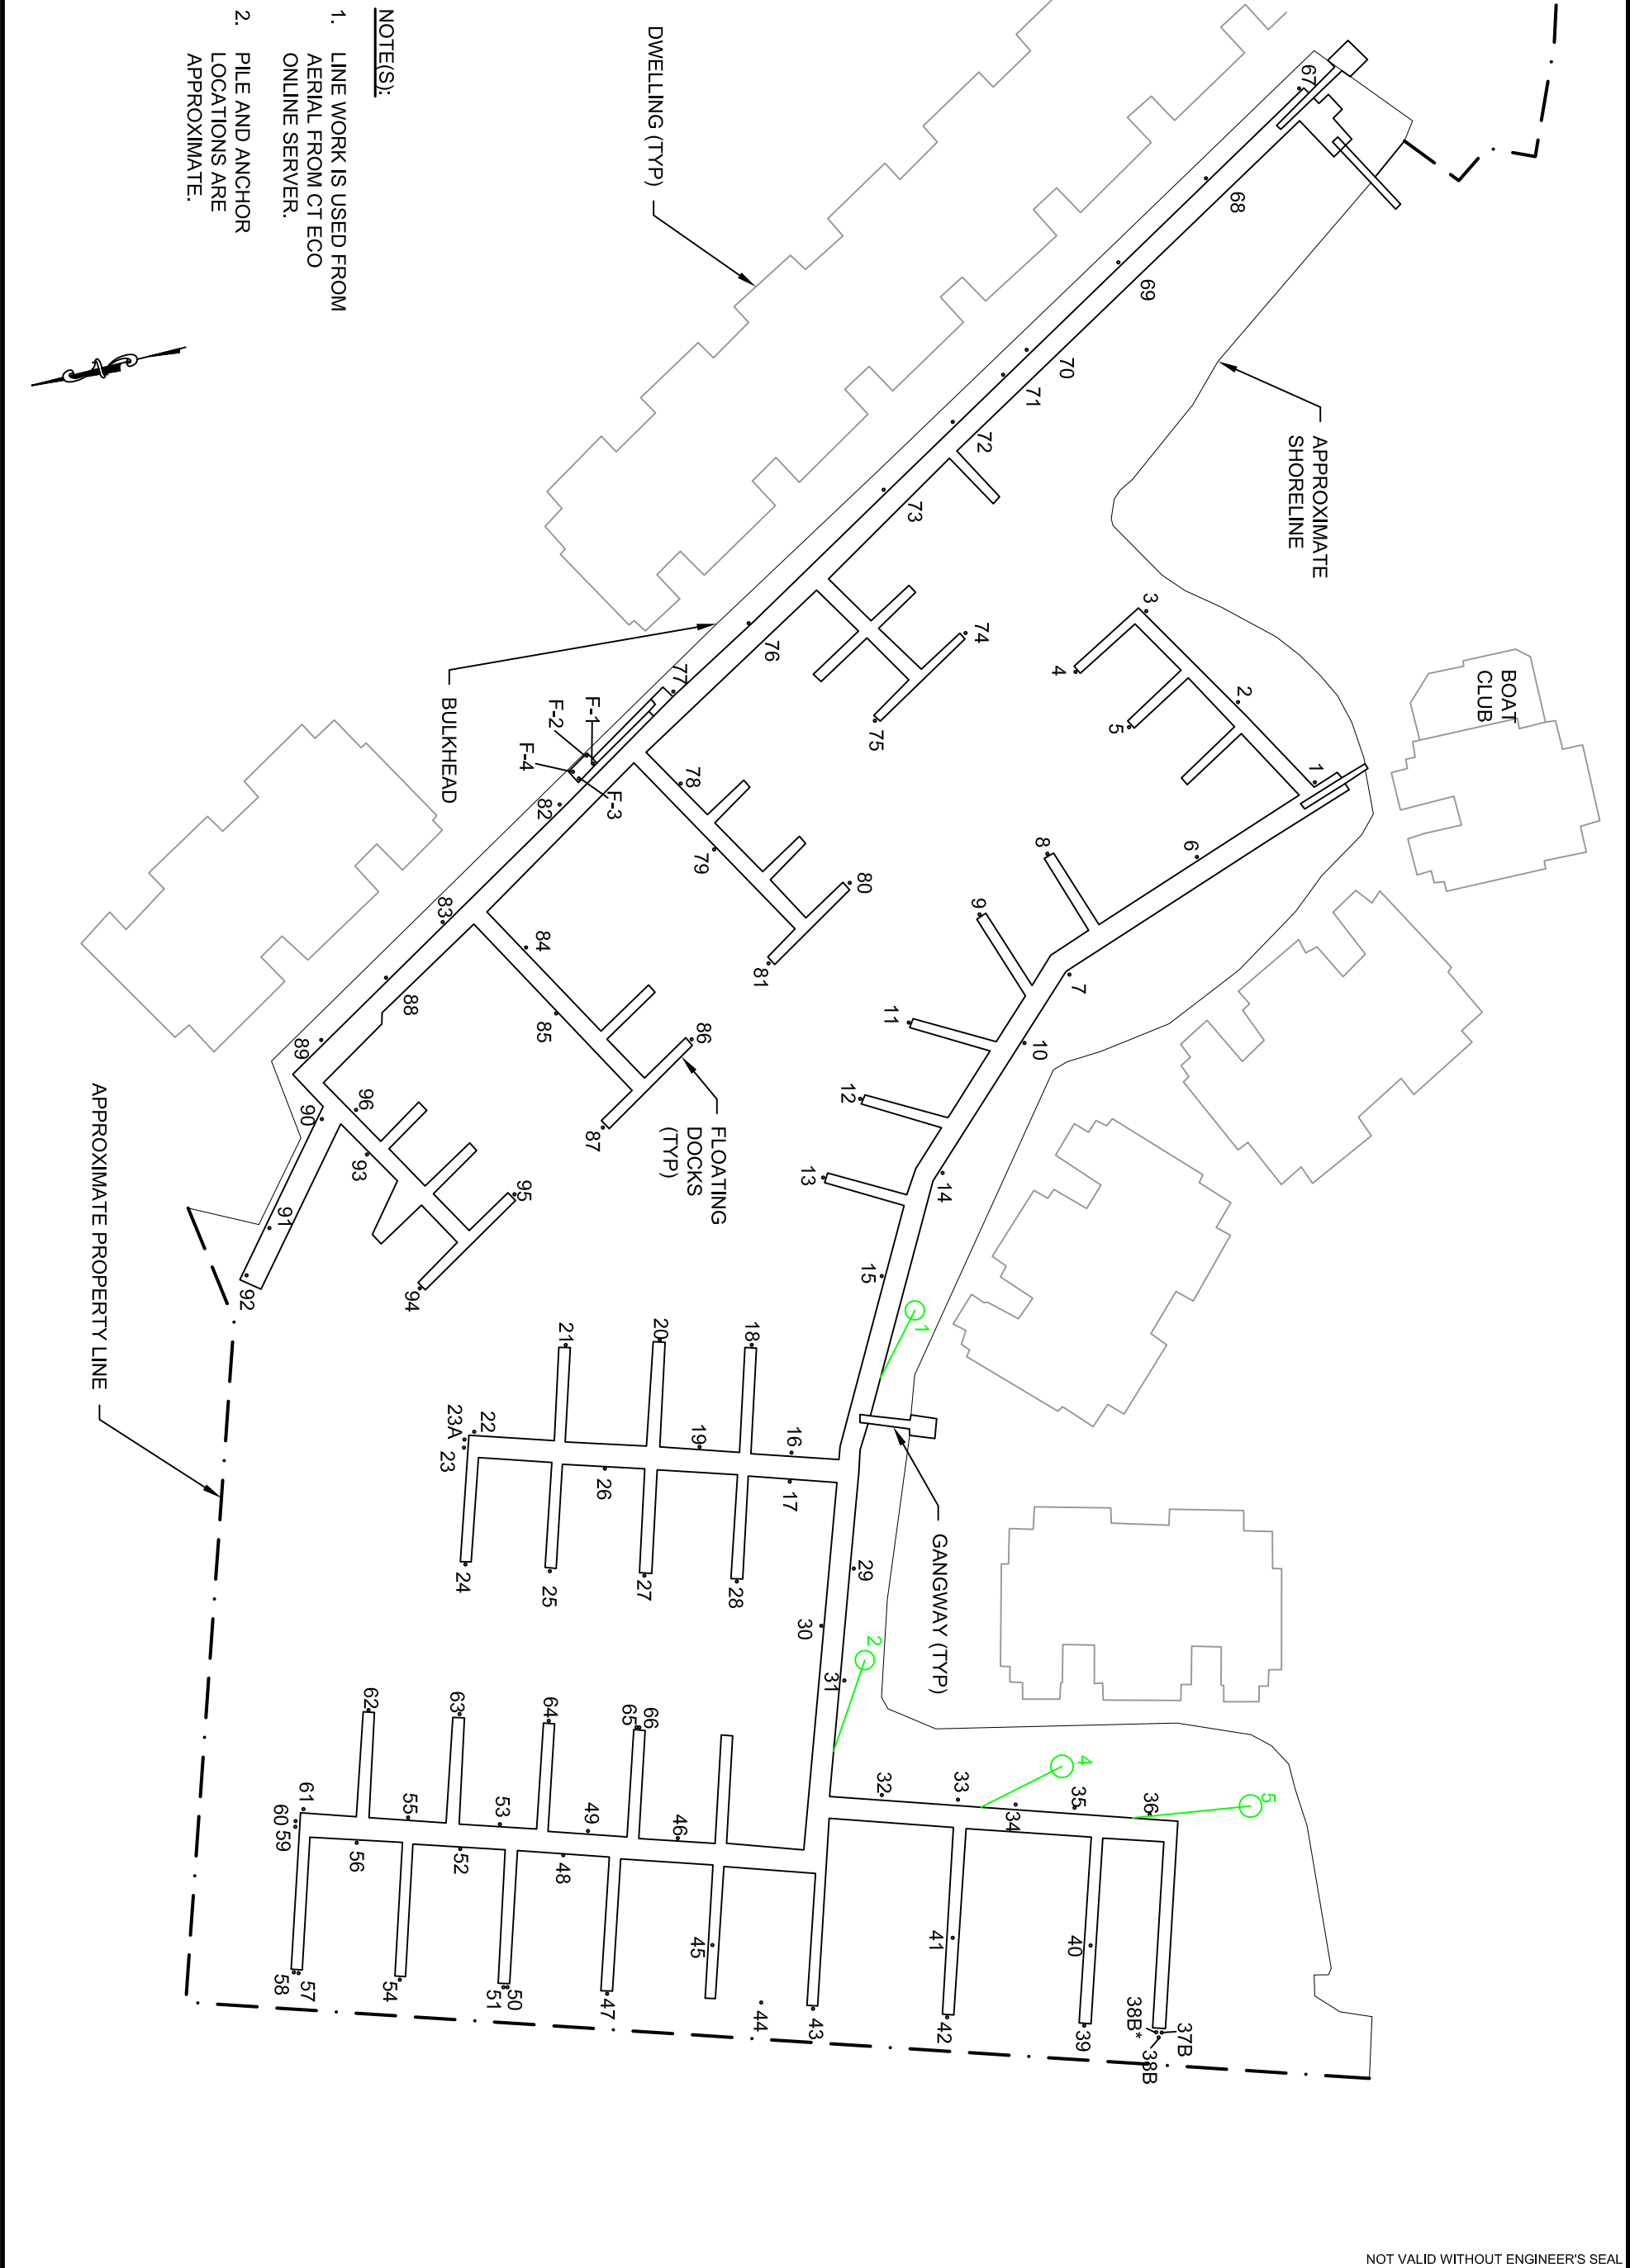
Pile Layout Sketch

The timber piles were observed to be in generally in **Fair/Good** Condition. However, significant damage was observed on 7 piles that are recommended for replacement. These piles include #6, #16, #22, #26, #79, #83, #85, F-1, F-3, and F-4 as identified in Pile Location Sketch included in Appendix B.

1. Replace pilings 6, 16, 22, 26, 79, 83, 85, F-1, F-3, and F-4 with a timber pile or composite pile.
2. Address pile guides damaging piles: 1, 9, 23, 24, 25, 27, 29, 32, 35, 38B, 45, 46, 50, 51, 54, 63, 64, 65, 66, 75, 80, 89, 96.

Recommendation	Time Frame
Replace damaged piles: 6, 16, 22, 26, 79, 83, 85, F-1, F-3, F-4.	1-2 years
Address pile guides damaging piles: 1, 9, 23, 24, 25, 27, 29, 32, 35, 38B, 45, 46, 50, 51, 54, 63, 64, 65, 66, 75, 80, 89, 96.	1-2 years
Undertake routine maintenance program to replace remaining piles at up to 25% of piles annually	3-10 years
Address need for storm anchors and replace if necessary	1-2 years
Considered increasing pile cut-off elevations for new piles	As installed
Perform a routine pile inspection	4-5 years
